OBTAINING SITE DATA

SCHICK GEOTECHNICAL, INC.

ADDRESS: 2286 N. Gloaming Way

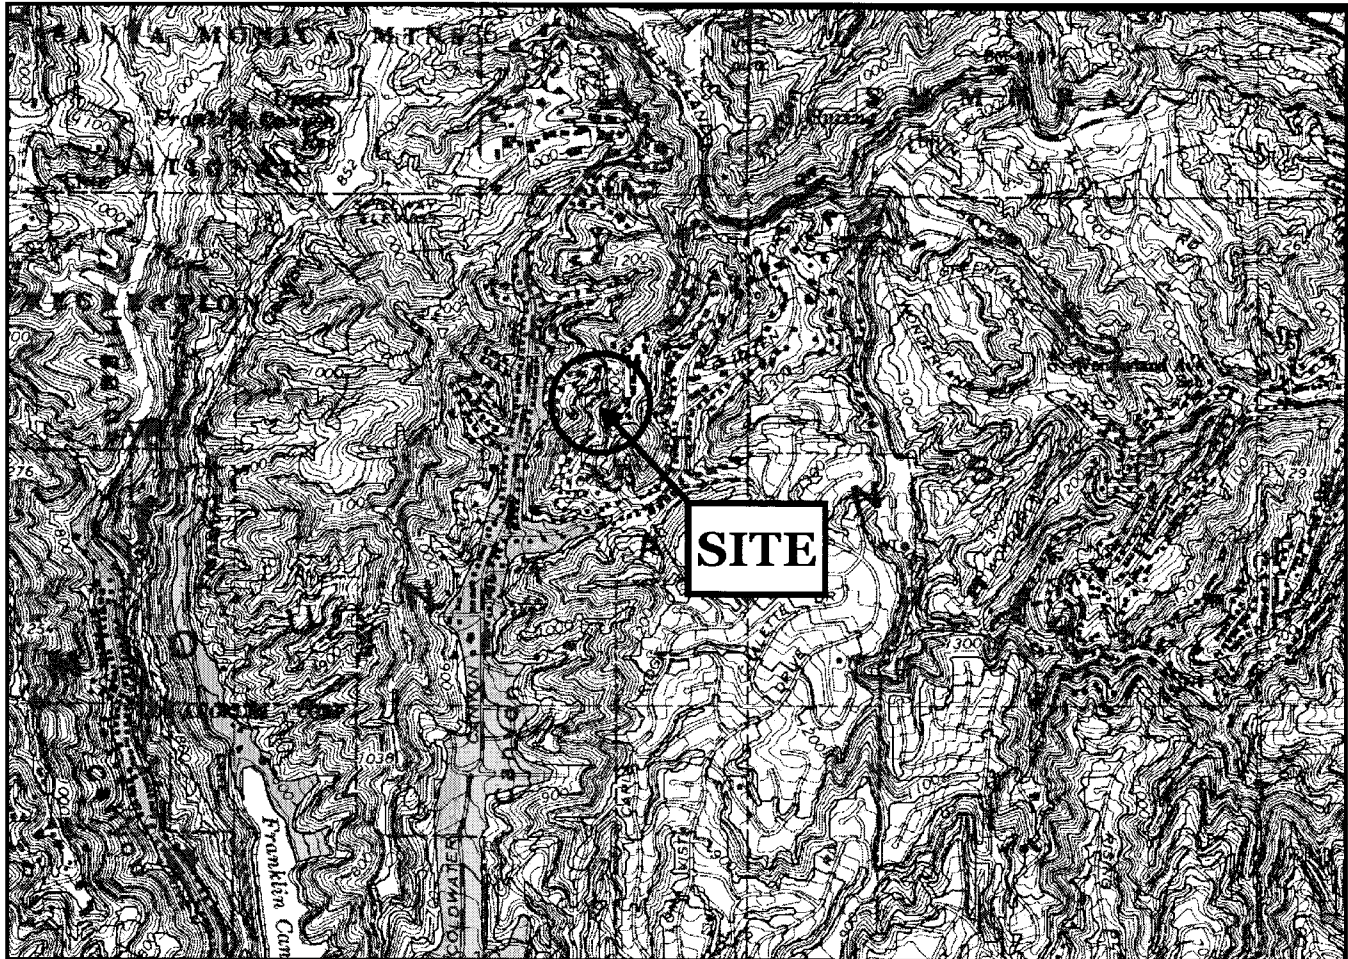
SEISMIC HAZARD MAP

REFERENCE: State of California, Seismic Hazard Zones, Beverly Hills Quadrangle, California Department of Conservation, Division of Mines and Geology, 1999

ZONES OF REQUIRED INVESTIGATION

LIQUEFACTION

Areas where historic occurrences of liquefaction, or local geological, geotechnical and groundwater conditions indicate a potential for permanent ground displacements such that mitigation as defined in Public Resources Code Section 2693 would be required.

EARTHQUAKE-INDUCED LANDSLIDES

Areas where previous occurrence of landslide movement, or local topographic, geological, geotechnical and subsurface water conditions indicate a potential for permanent ground displacements such that mitigation as defined in Public Resources Code Section 2693 would be required.
